Filter bottom repair plate.

The EZ-lock filter screen is held in place by two small tabs at the bottom of the filter canister. These tabs or the bottom can get damaged by dropping the filter cartridge while the spa is empty. In the event of a broken tab or a cracked bottom, please follow these instructions.

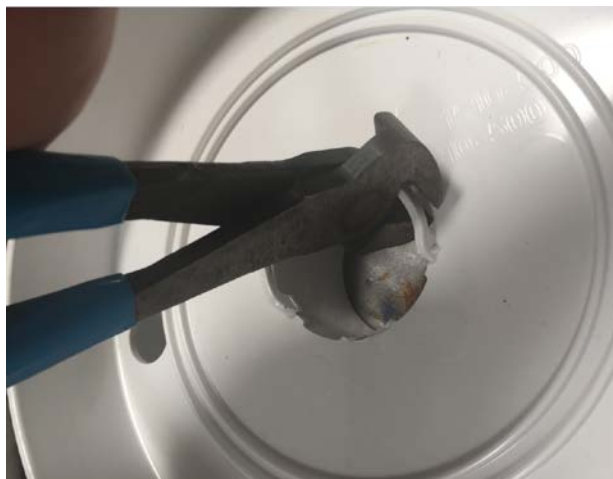
With end-cutting pliers, cut off the tabs, as close as possible to the base.

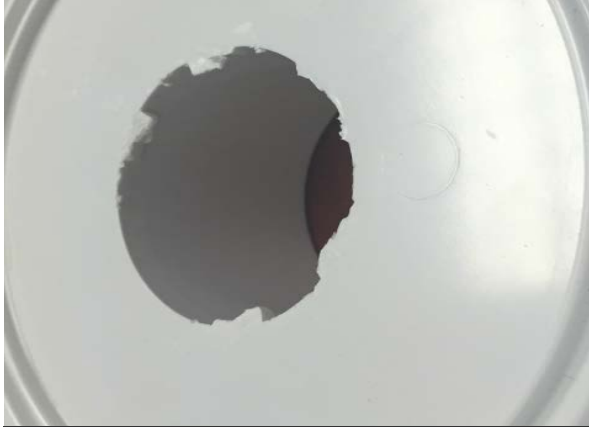
With sandpaper flatten and smooth the remainder tabs.

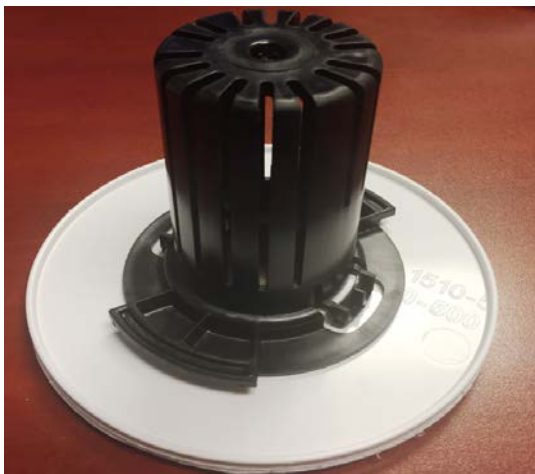
Install the EZ-lock filter screen on to the repair plate.

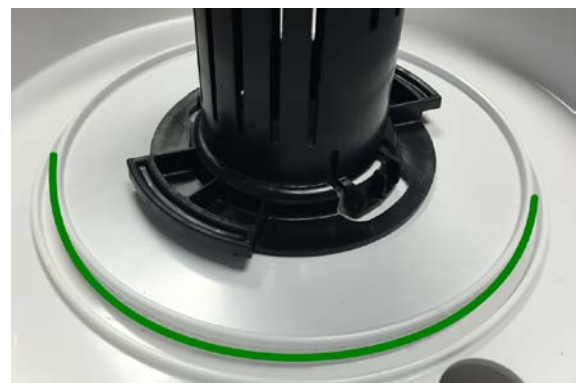
Align and mount the repair plate on to the filter bottom. Hold in place for about a minute. Finish by adding a large bead all around the plate to for better seal.
